Nuclear News

May 2017

Wolf Creek: Water jet peening of reactor vessel nozzles

Wolf Creek is the first U.S. nuclear power plant to implement this process, with the goal of mitigating primary water stress corrosion cracking in reactor vessel nozzles.

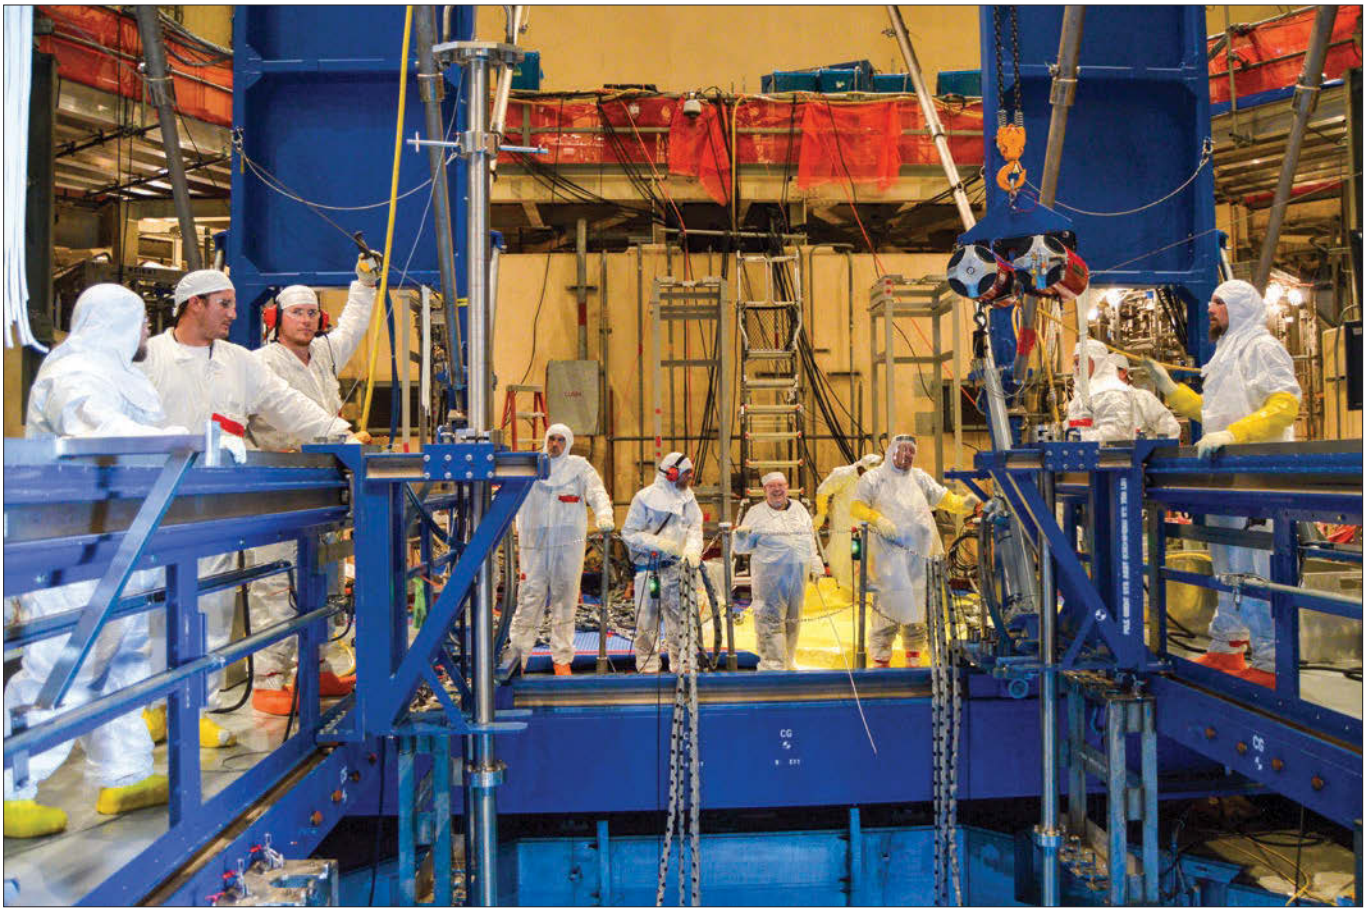
Water jet peening crews from Mitsubishi Nuclear Energy Systems and AZZ/WSI observe the refuel pool from above as both peening tools perform the process inside the reactor vessel. (Photos: Scott Bolley/Wolf Creek Nuclear Operating Corporation)

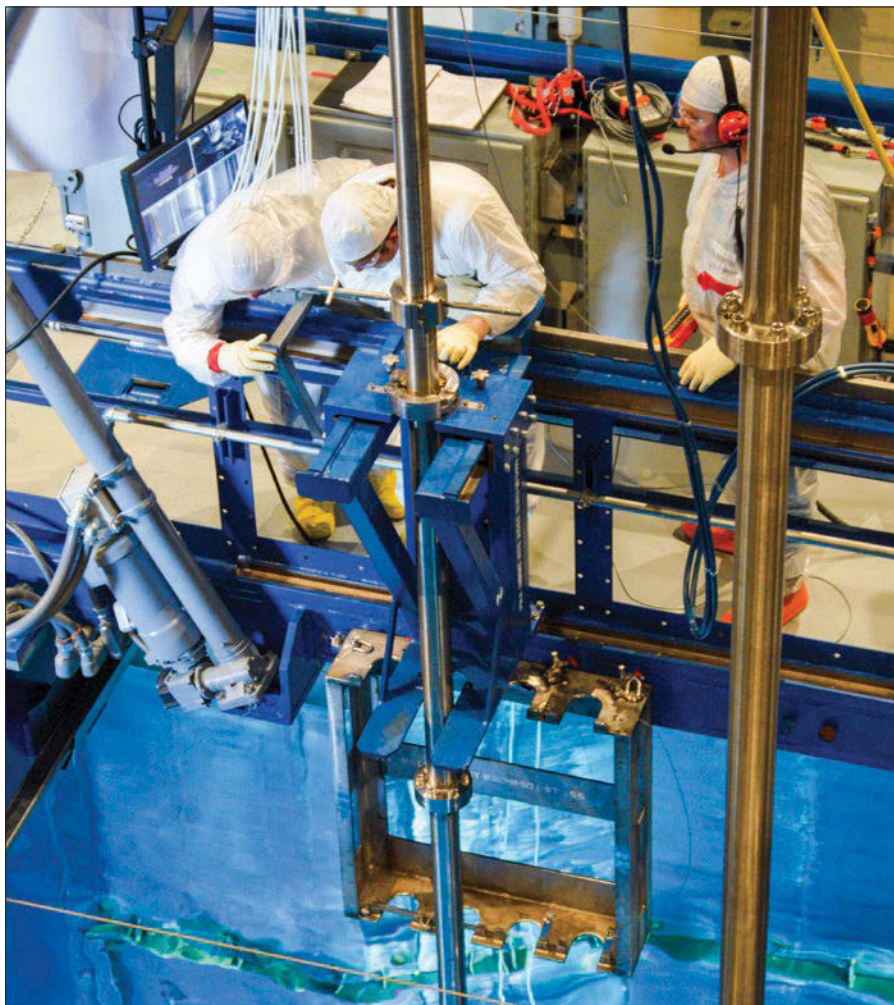
Workers lower the peening tools into the reactor vessel via metal extension rods, positioning them to begin peening a particular area.
